NTSB National Transportation Safety Board

Tunnel Design, Inspections, and National Standards

Dan Walsh

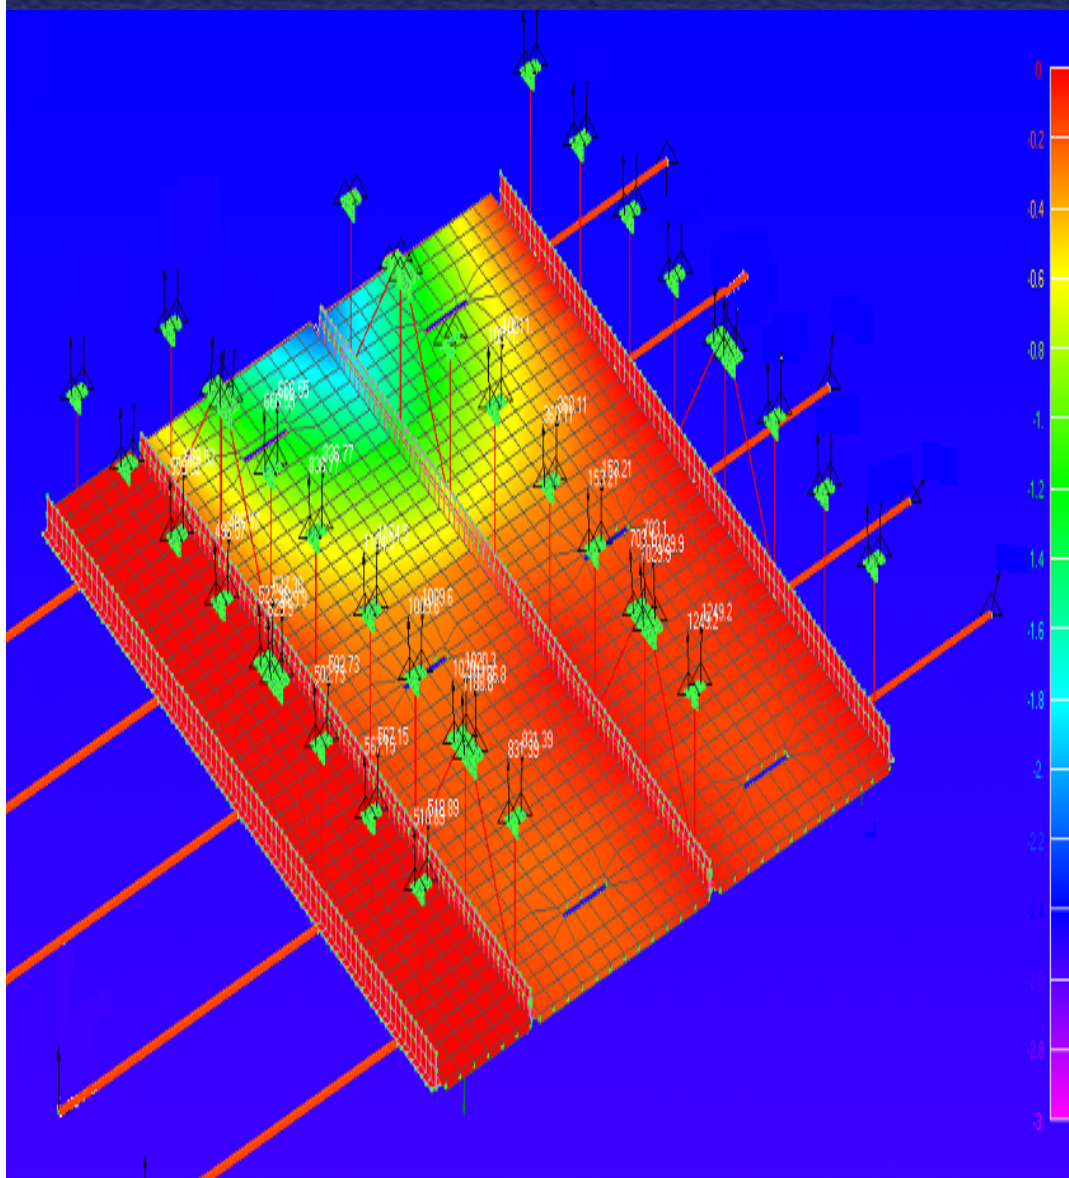
Finite Element Analysis

- One hanger removed, loads remained below 6,350 pounds
- Two or more hangers removed, loads remained below 25,400 pounds
